# Rapid WHB retubing at IPL Mount Isa site

## Challenges for IPL Mount Isa

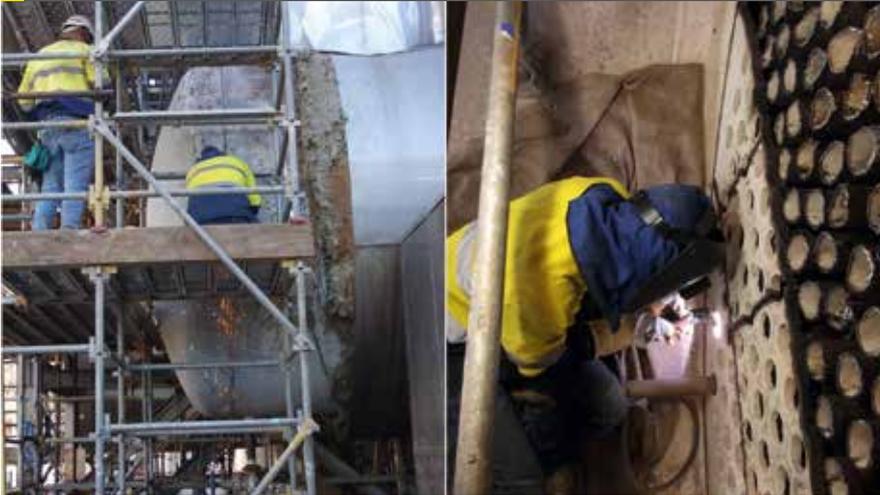
Fig 3: Cutting WHB cold end vestibule (left) and tube sheet (right)

To commence repairs, access was gained from the cold end plenum by cold cutting the dished end from the plenum cylinder, as shown in Fig. 3.

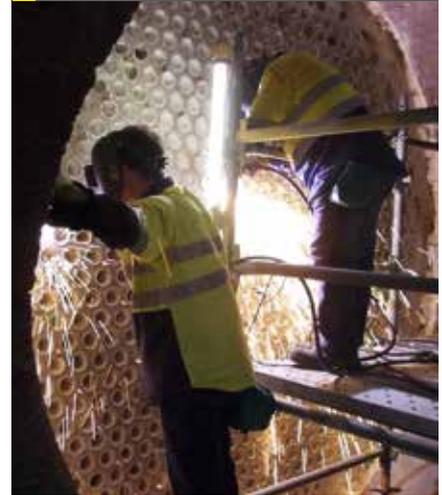
Fig 4: Hot end tube cutting

After removal of the hot face refractory, tubes were released from behind the hot end tube sheet and the hot end tube sheet removed in sections, as shown in Fig. 4. This allowed the tubes to be withdrawn from the cold end.

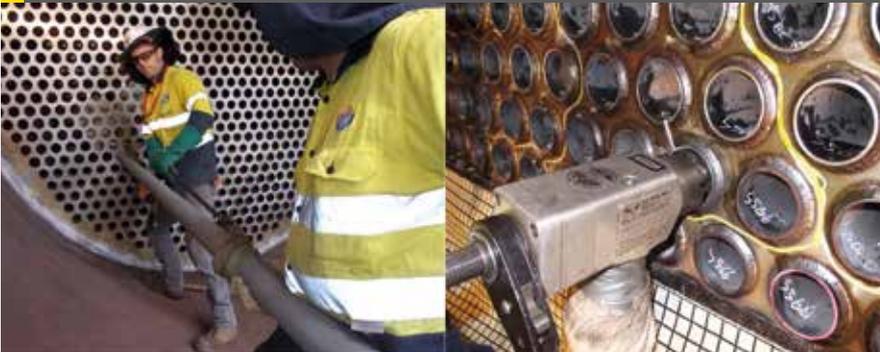
Fig 5: Insertion (left) and cutting (right) of new tubes

no manways in the boiler shell, RCR Energy removed hand holes (in their entirety) to provide the access necessary to reinstate and inspect tube supports and guide tubes during insertion. The cold end tube sheet was installed and tubes were loaded, tacked, trimmed and welded, as shown in Fig. 5.

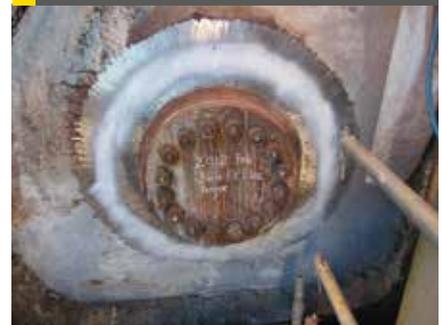
Fig 6: Marking out hand holes prior to complete removal

Re-welding of the complete hand holes was carried out with temper bead welding to avoid stress relieving of the boiler shell, as shown in Fig. 6. This technique was a success with weld hardness limits met throughout.

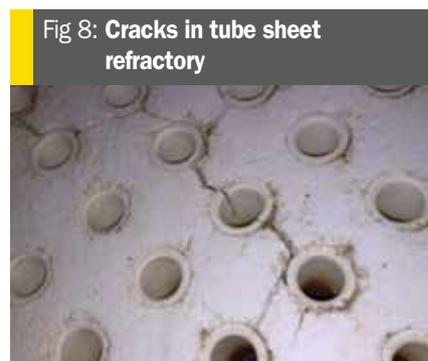
To make matters worse, this labour-intensive and time-consuming technique for protecting the WHB tube sheet often causes other adverse effects. The monolithic refractory structure that is created on the tube sheet is prone to cracking when the boiler is cycled from ambient temperature up to operating temperature, as shown in Fig. 8.

Fig 8: Cracks in tube sheet refractory

In order to provide adequate tube sheet protection for the long run, avoid refractory cracking due to thermal cycling, and provide a solution that could be installed as quickly as possible, IPL management employed the use of MECS® HexPro™ WHB ferrules manufactured by Blasch Precision Ceramics. In contrast to conventional ferrules, HexPro™ ferrules utilise hexagonal heads so that no mortar is required in between the ferrules. Thus the ferrules can simply be put into the tube sheet, as shown in Fig. 10. The result is a 67% reduction in ferrule installation time. In the case of the IPL Mount Isa boiler retube project, this time proved to be very valuable; thus the higher material cost for the ferrules was justified by the speed of installation.

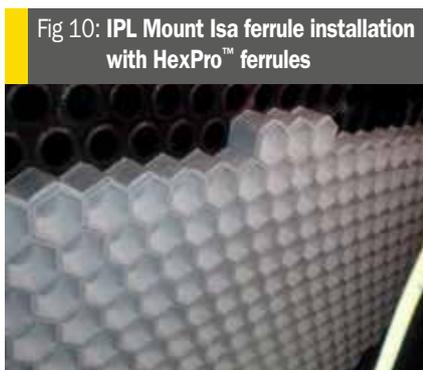
Fig 10: IPL Mount Isa ferrule installation with HexPro ferrules

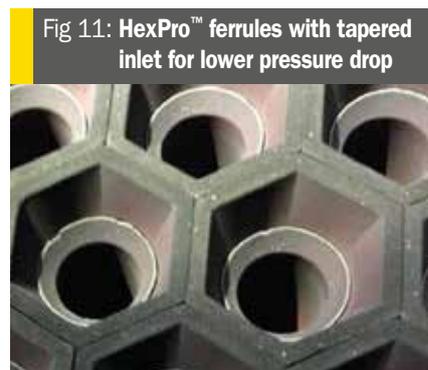
Fig 11: HexPro ferrules with tapered inlet for lower pressure drop

As an added bonus, the ferrules selected by IPL Mount Isa also had a lower pressure drop compared to conventional cylindrical ferrules because the hexagonal ferrule heads allowed for the use of a tapered inlet, as shown in Fig. 11.
