Blasch Precision Ceramics Case Study

VectorWall™ Mixing Checkerwall

Tessengerlo Kerley, Inc. Reduces Fuel Gas Usage in Claus SRU by 50%

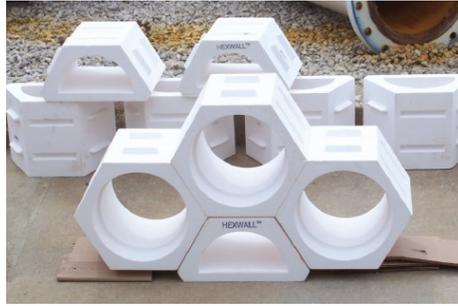
Figure 1: Hex block

Key to the hex block design was a deflector tile that directed gas flow in a pattern to increase gas mixing and therefore, turbulence. The deflector tile

performed extremely well in increasing gas mixing and turbulence in the incinerator combustion chamber. During the Claus unit's 2009 turnaround, the old checker wall was

In 2009, TKI had installed Blasch hex head ferrules for its Claus burner and Claus off gas incinerator. Since they were pleased with the reliability and performance of the ferrules, TKI approached Blasch to assist with the checker wall issue. Engineers from both Blasch and TKI worked closely together to design a custom VectorWall using interlocking hex blocks (Fig. 1) to increase reliability of the wall and turbulence in the incinerator combustion chamber.

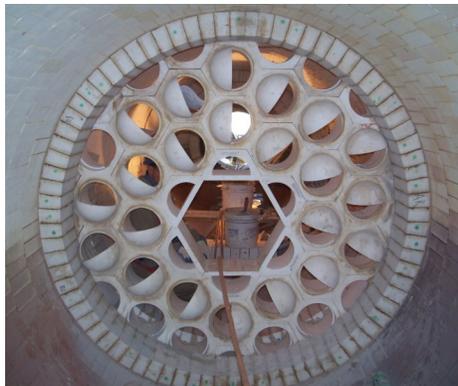
Figure 2: Newly installed hex block VectorWall

removed and the new VectorWall was installed (Fig. 2).
